210 MW Bison 4 Wind Project, Minnesota Power (PSC Case No. PU-13-127)

Permit Compliance Review

Reporting Period: August 1st, 2014 -- November 21st, 2014

Prepared By: Houston Engineering, Inc. / Emmy Baskerville, Environmental Scientist and Bart Schultz, Project Manager

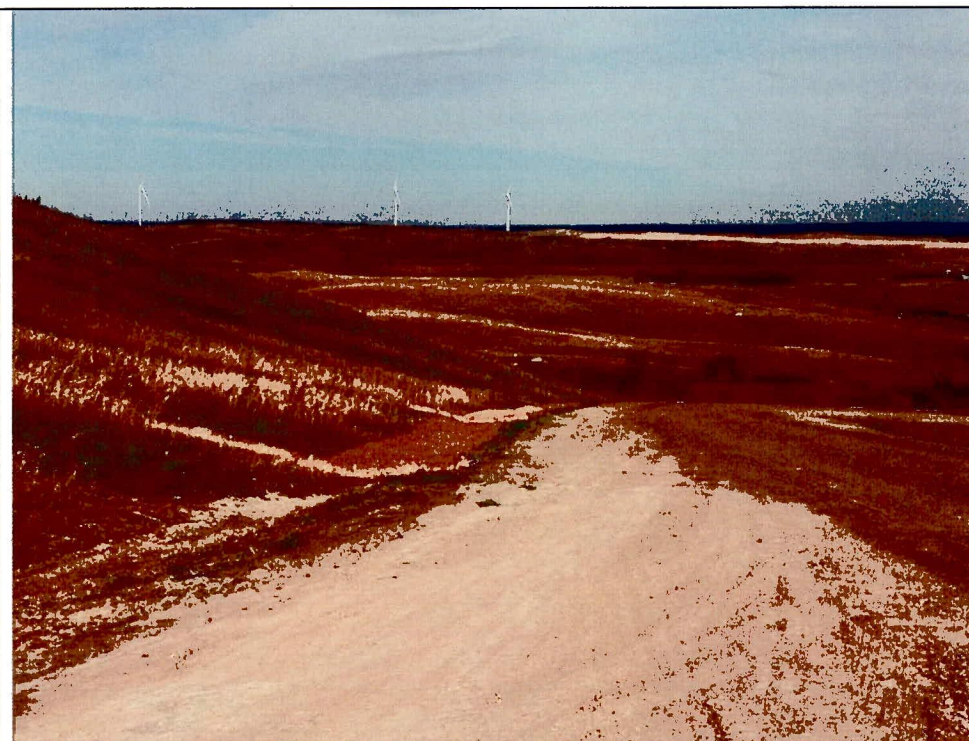
Photo 1: Site 421, showing erosion control measures.

421: biorolls, erosion control in place

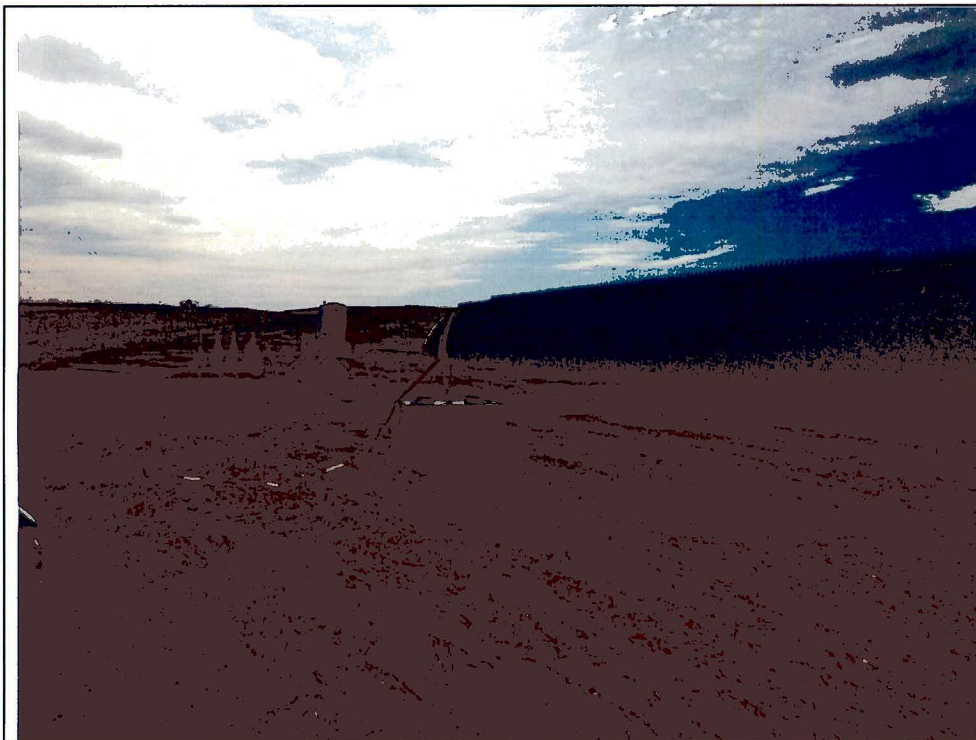
Photo 3: Site 457, showing turbine laydown area.

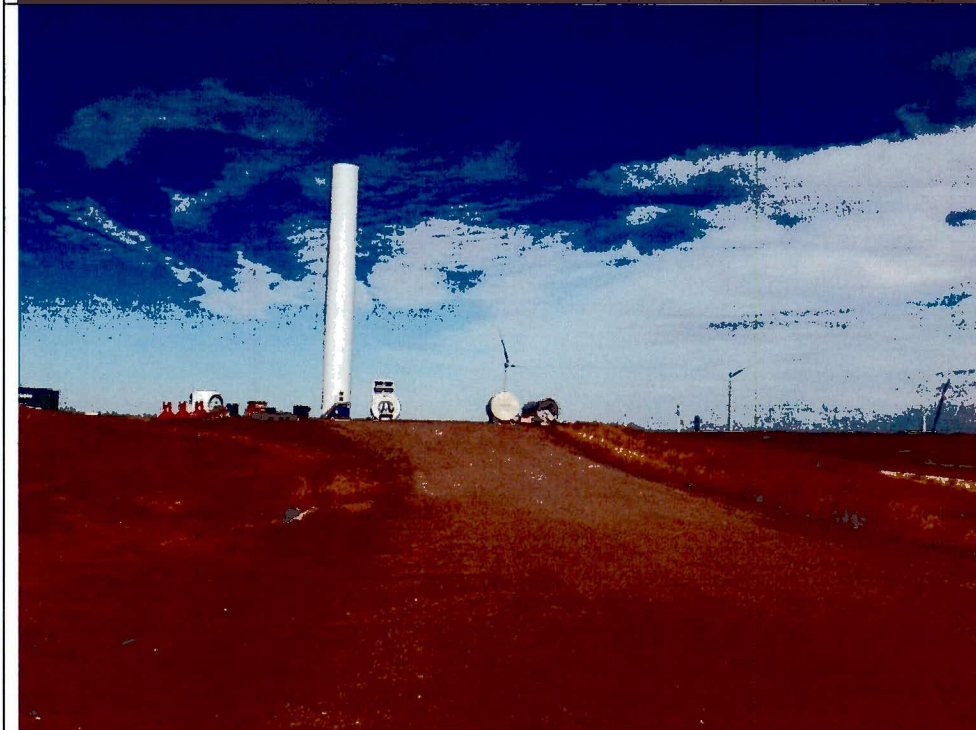
Photo 4: Site 433, actively under construction.

433: under const - pic

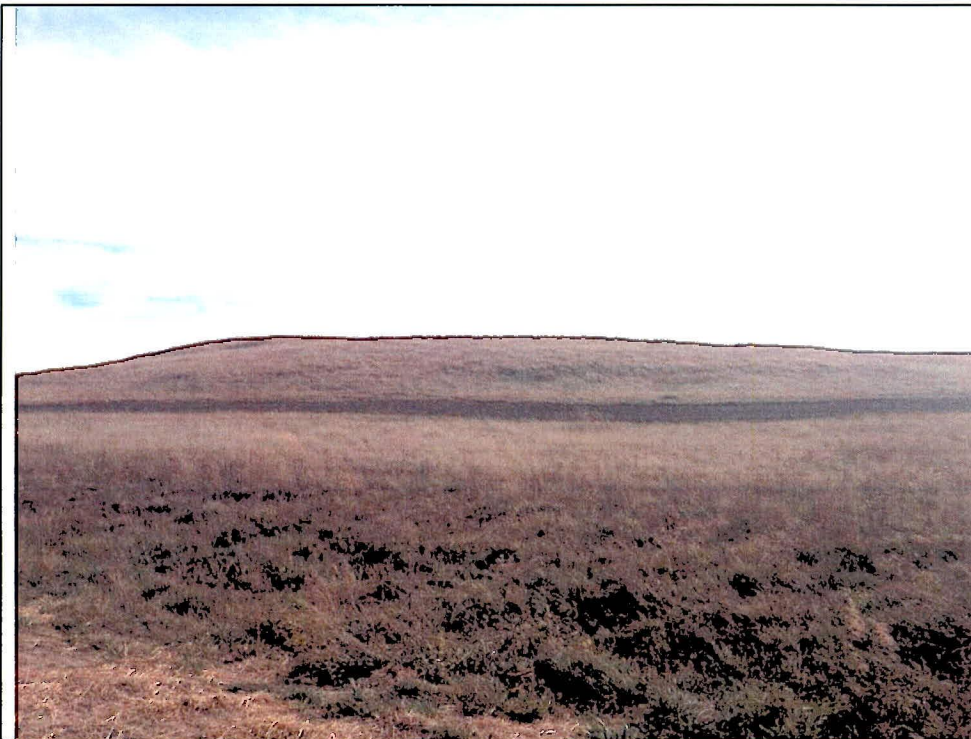
Photo 5: Site 434, showing avoidance of significant archaeological site.

434: ~~at~~ major archaeological site.
Avoided

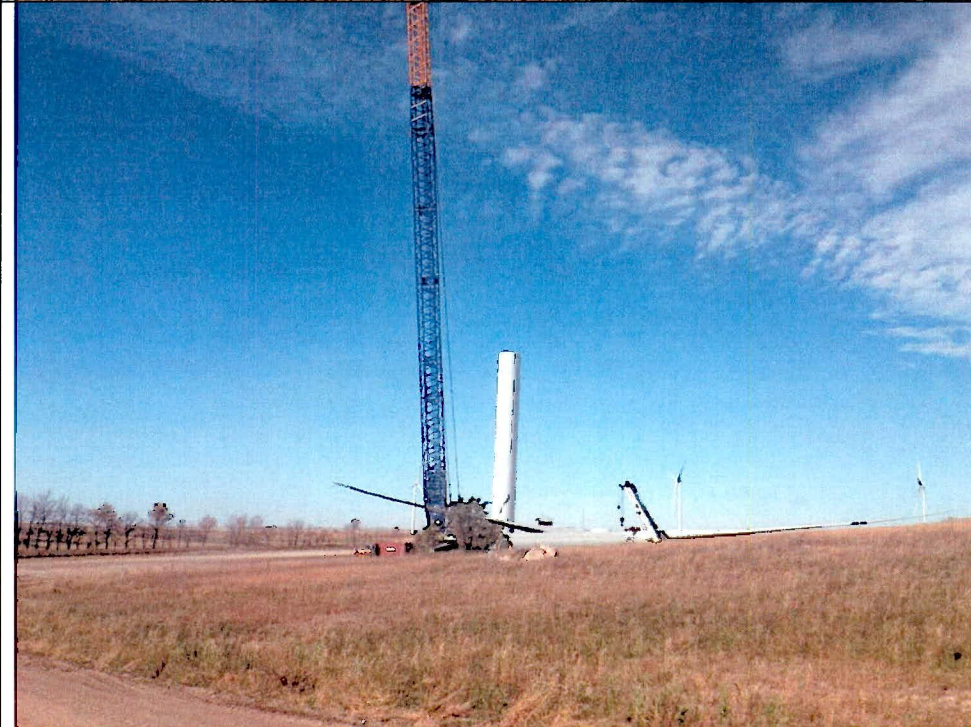
Photo 6: Active construction on pad for turbine 452.

452: under const. crane on site

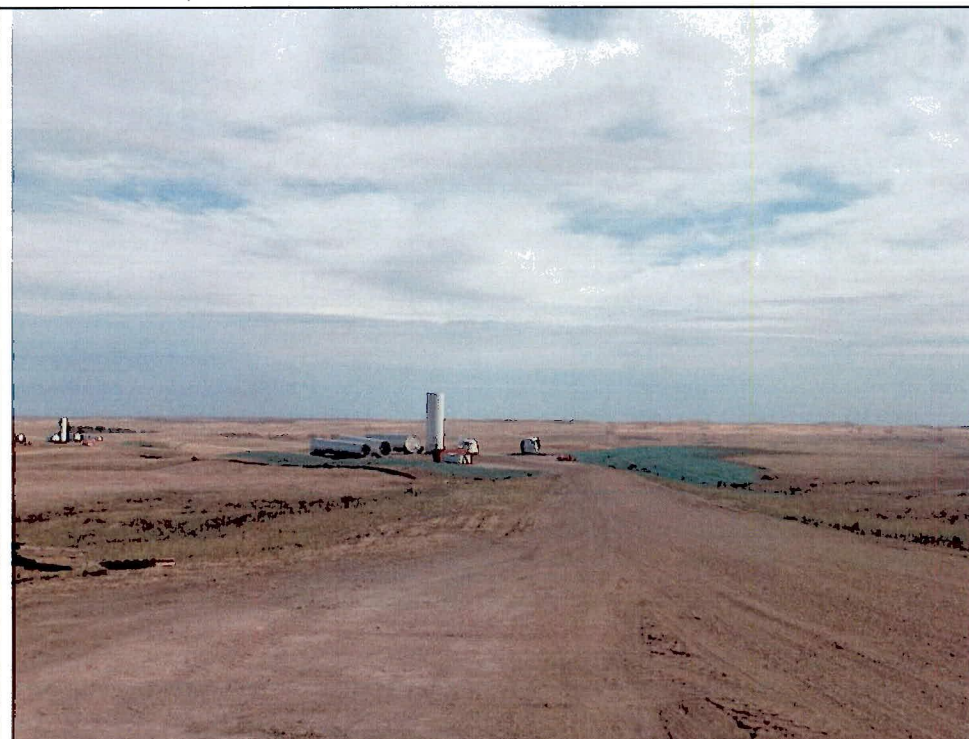
Photo 7: Site 439, recent hydroseeding.

439: ~~by~~ recent hydro SEED - PIC
silt fence observed

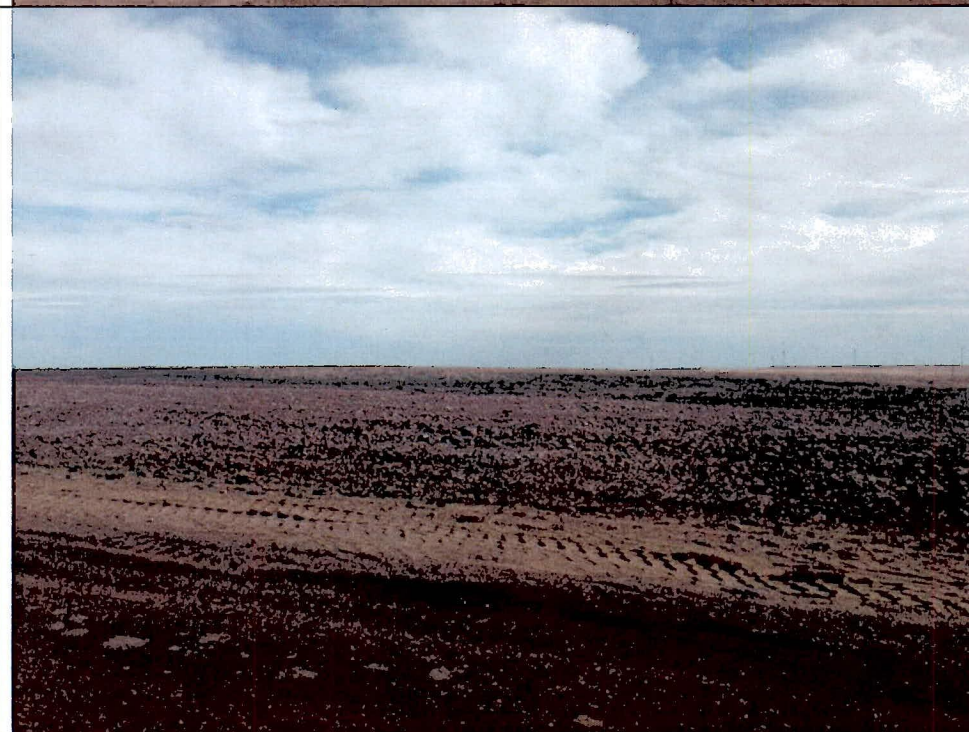
Photo 8: Site 440, recent seeding.
